THE PREDICTION OF STRUCTURAL FAILURES.

A thesis submitted to the University of
London for the degree of Doctor of Philosophy.

BY
PAUL SIBLY.

March . . 1977.

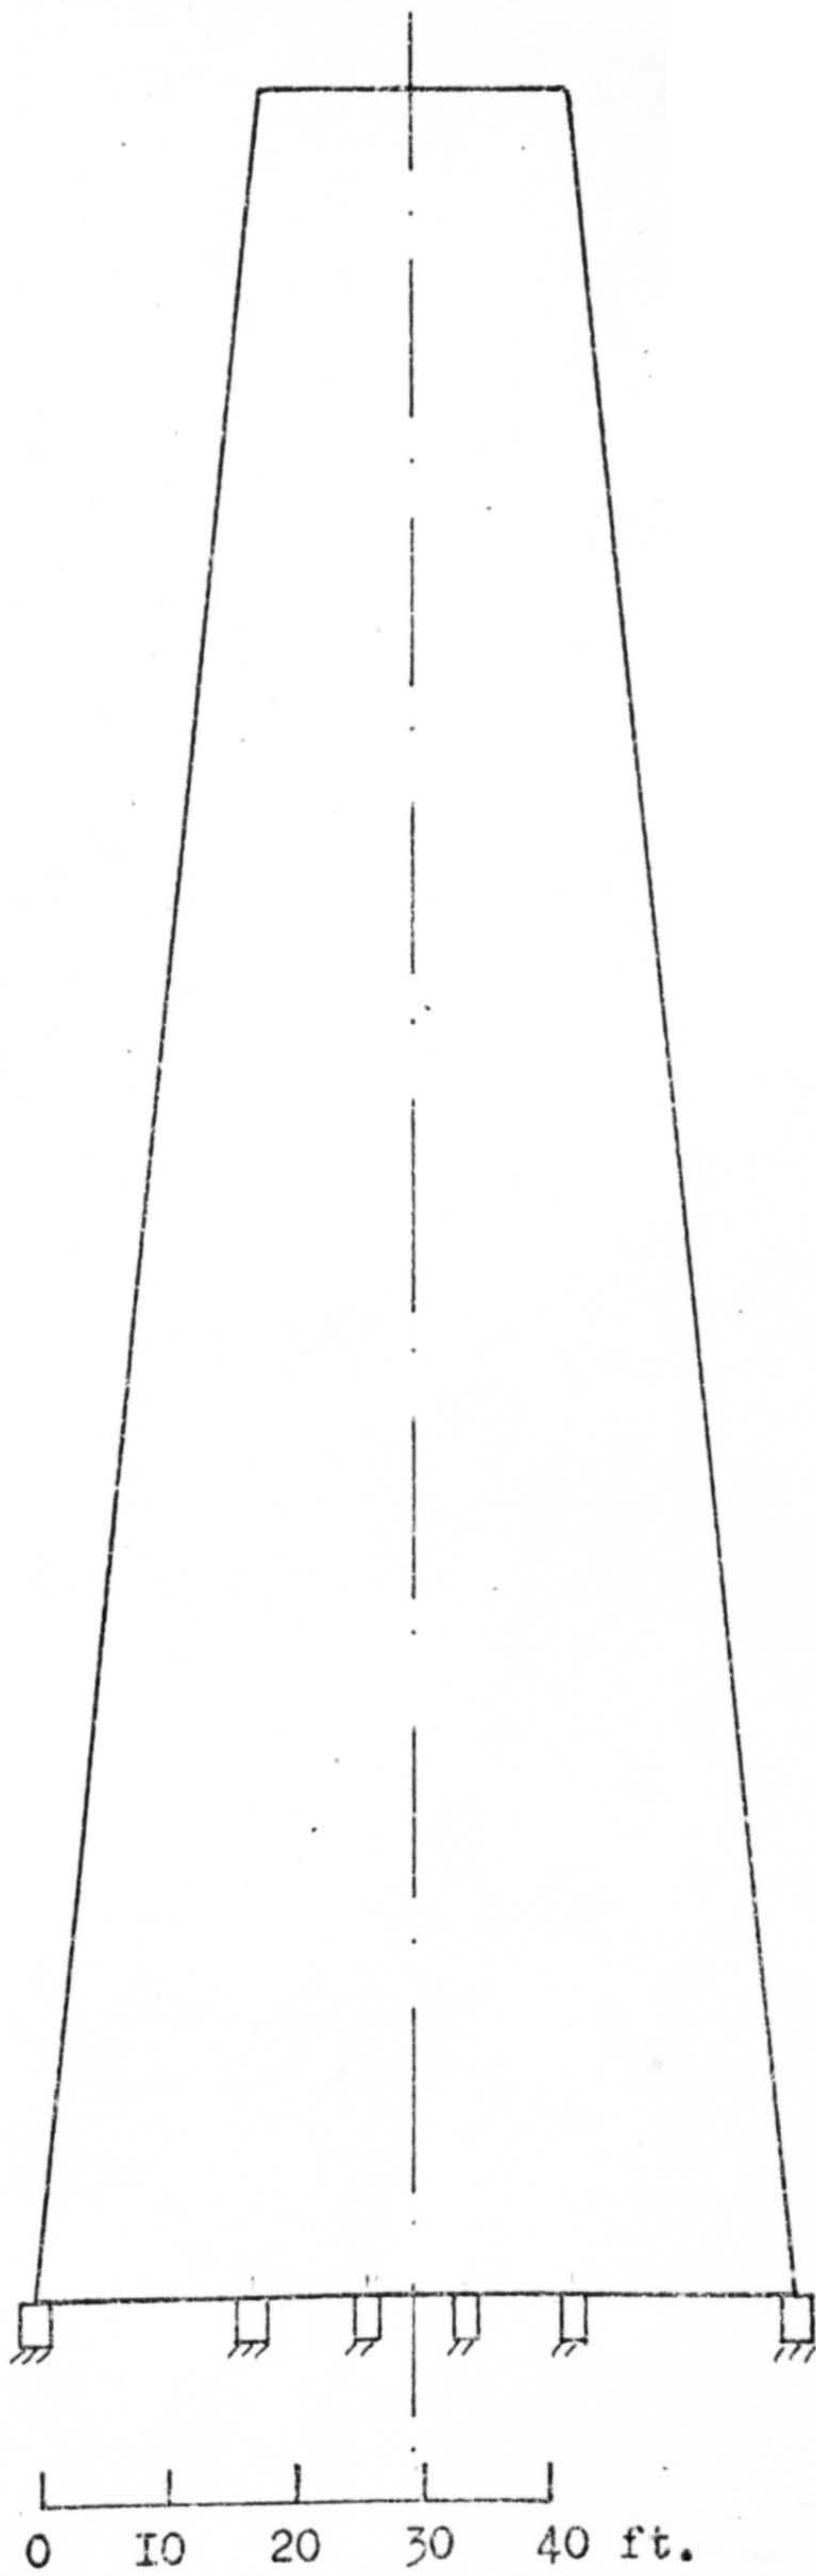
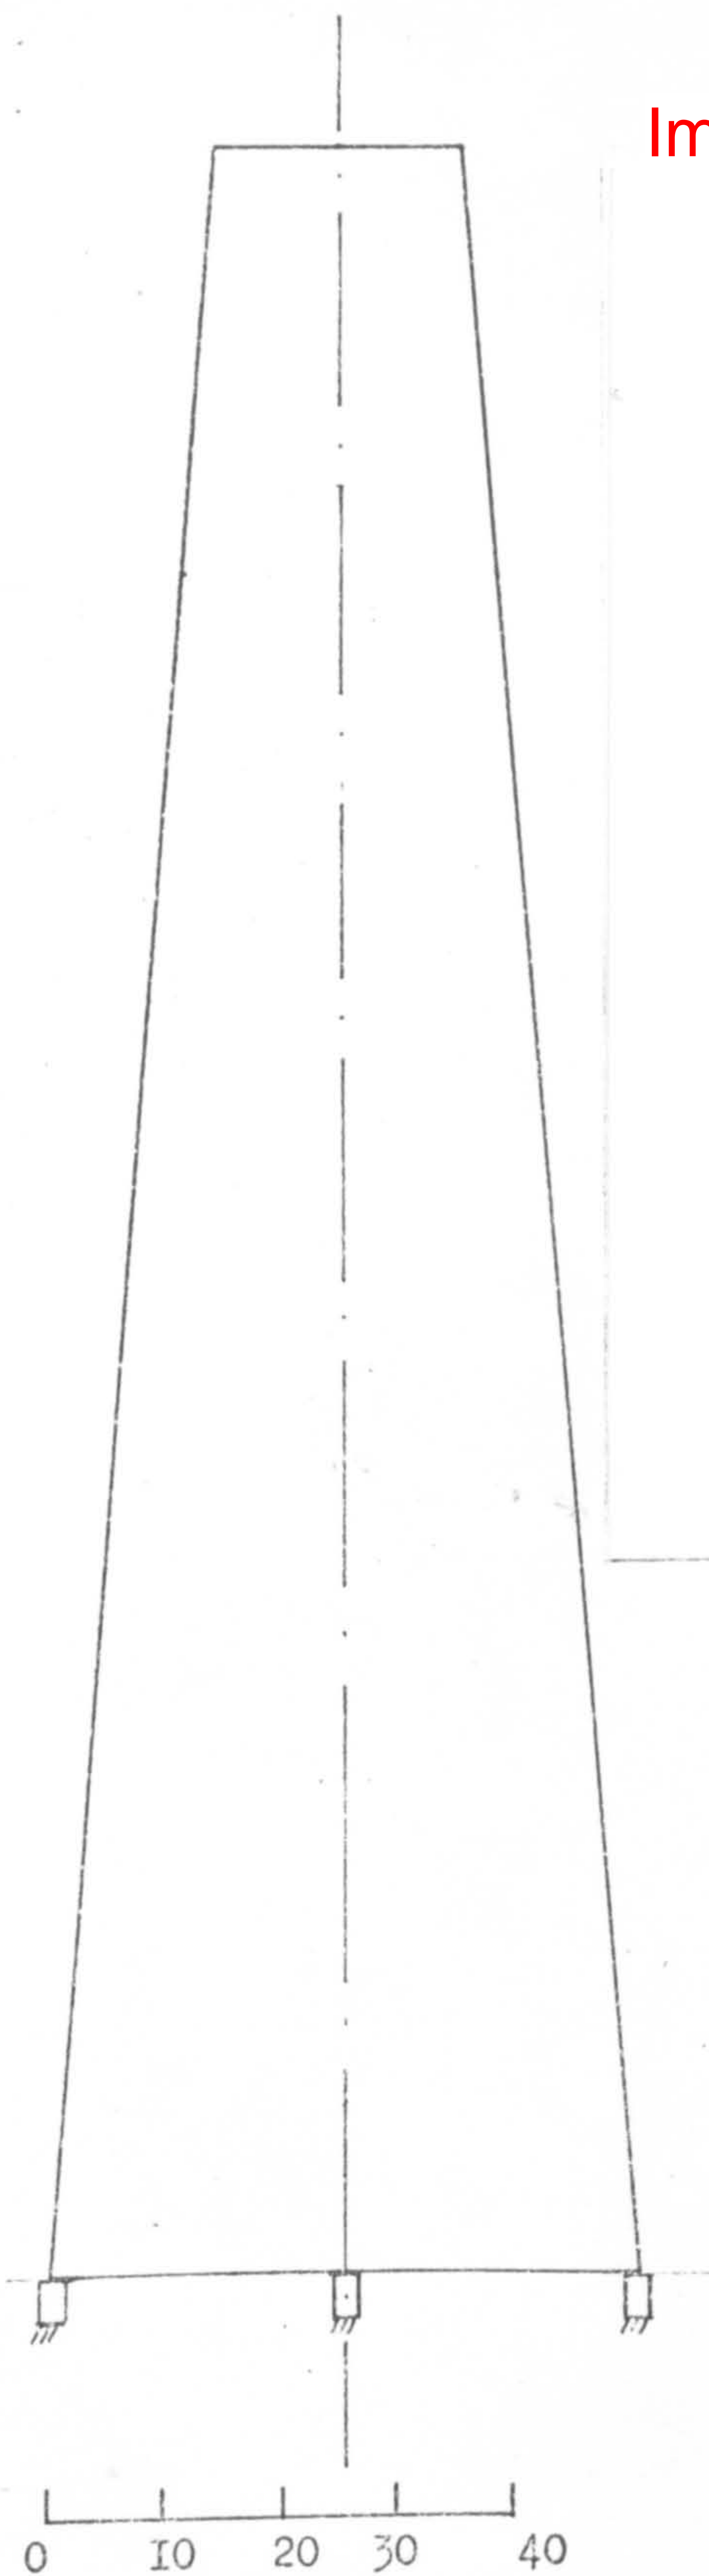
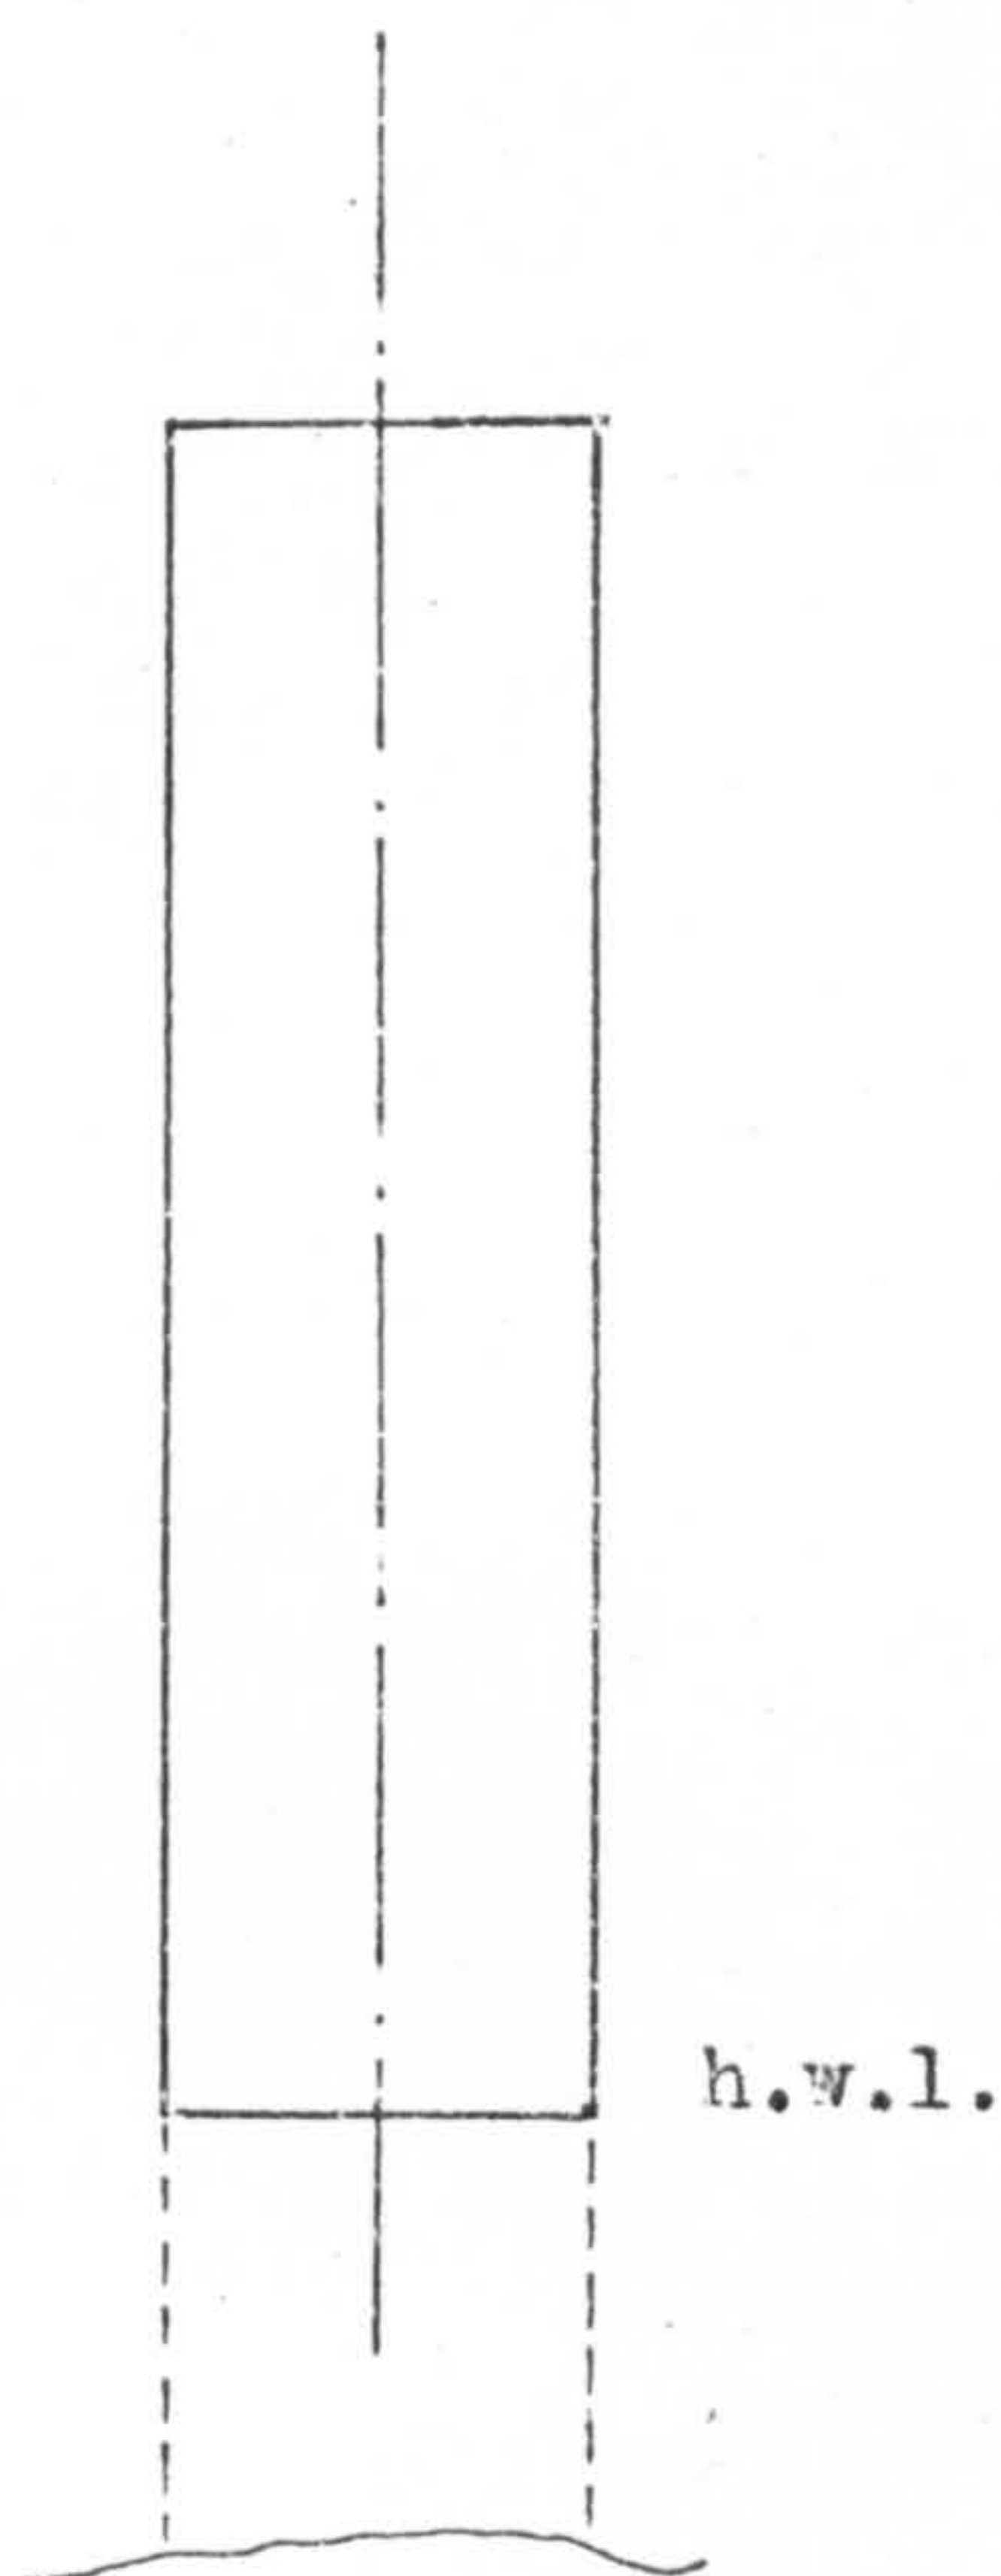
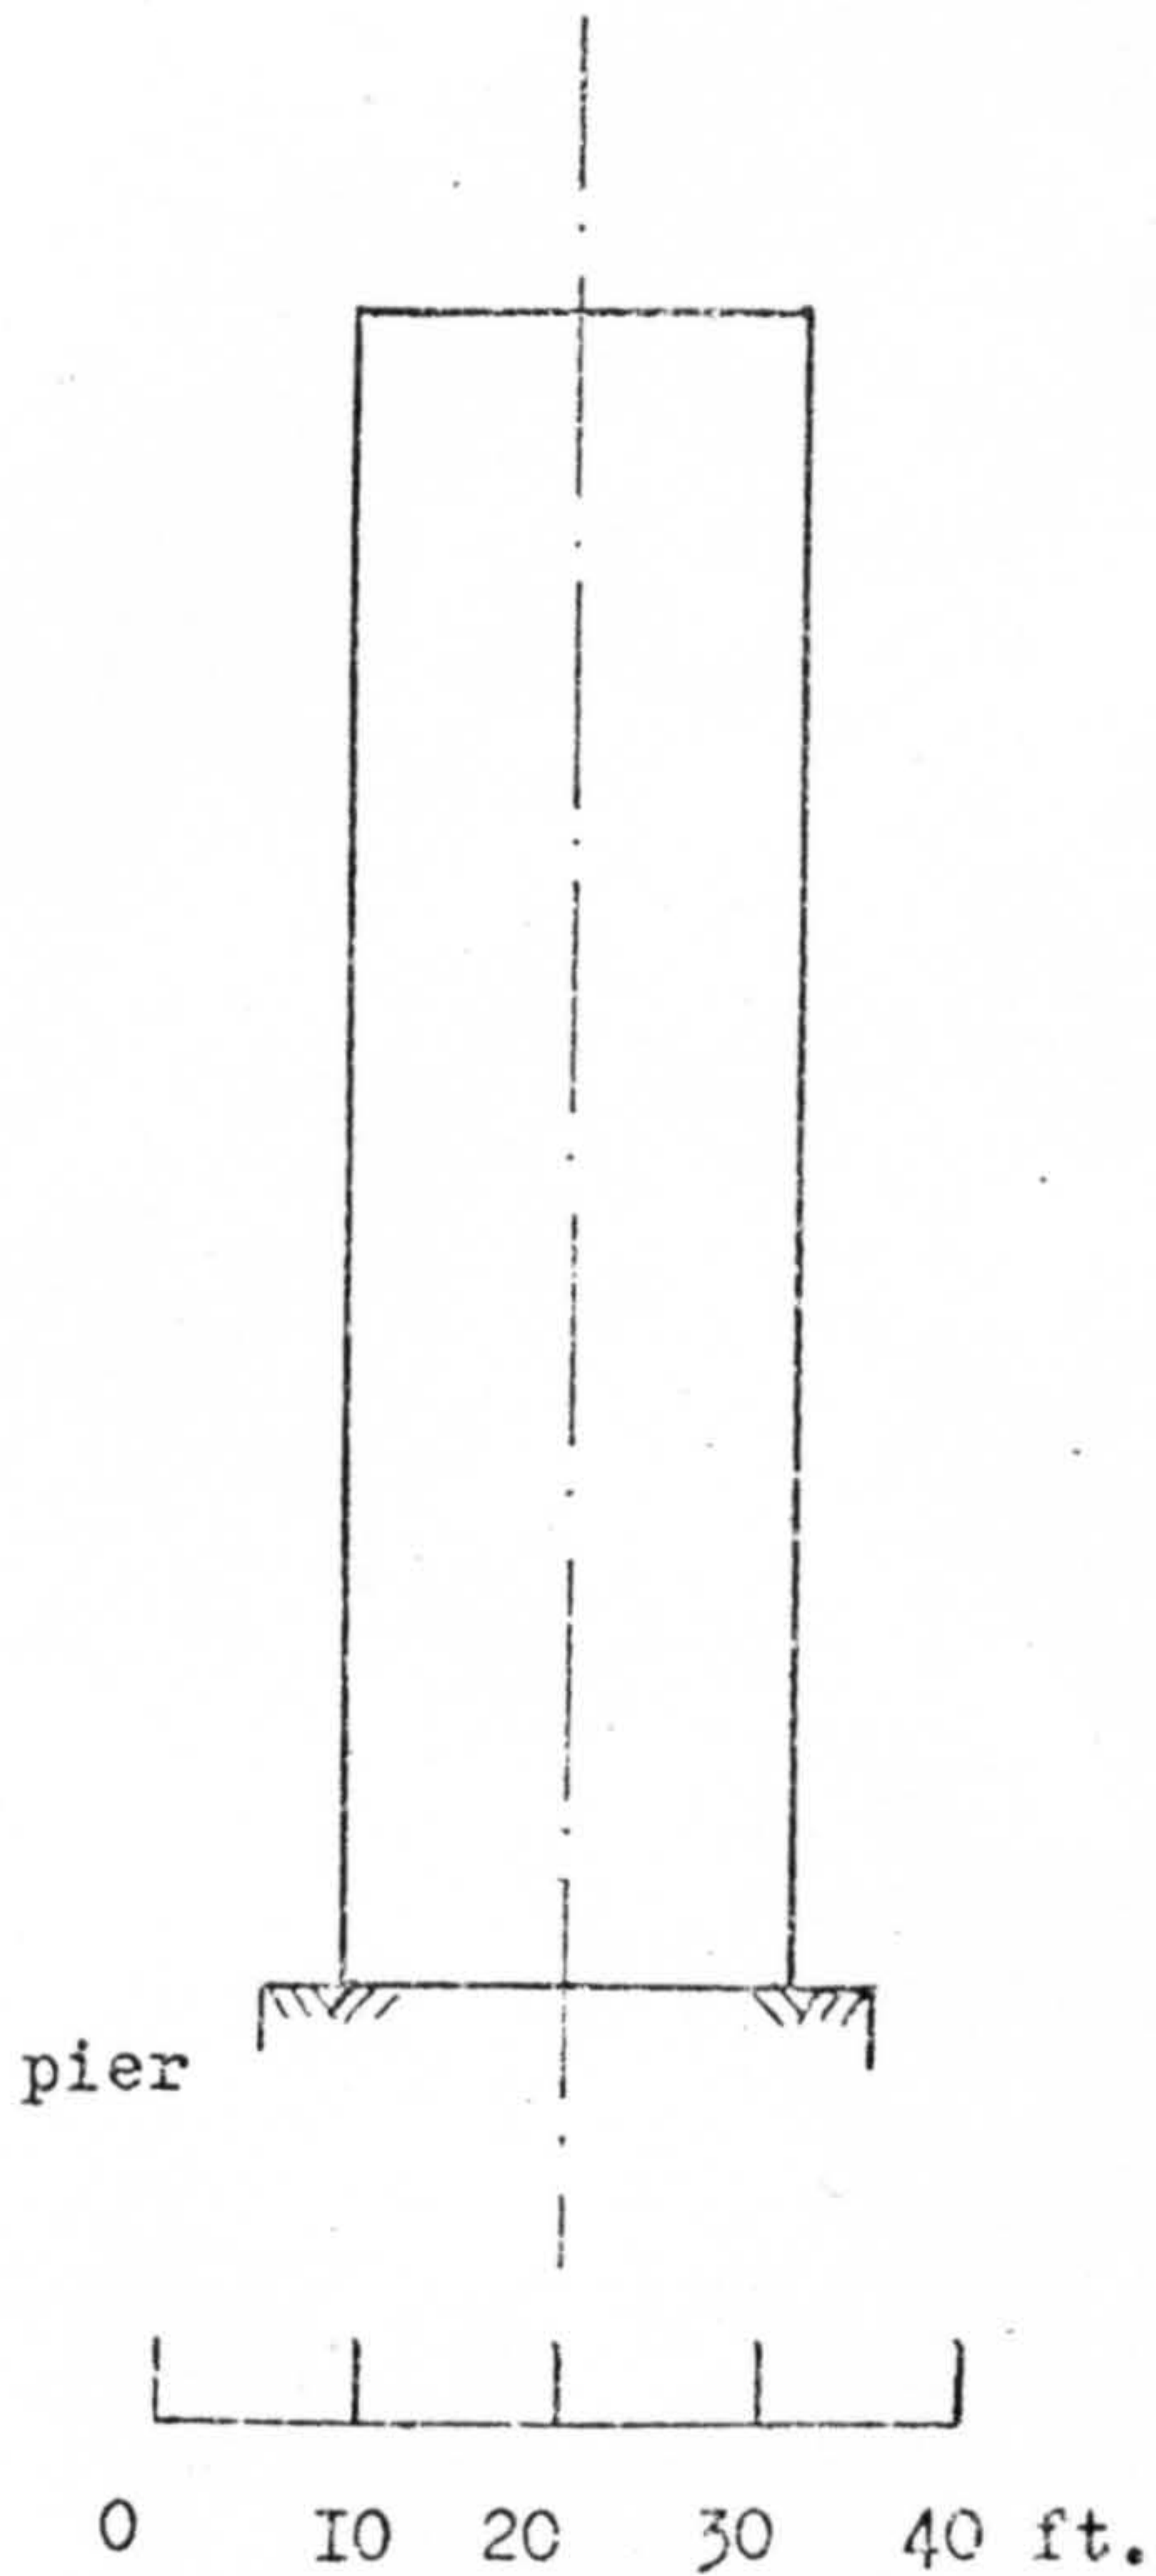
The author did not say much more about pier design but even the criterion quoted is sufficient to suggest that the Tay Bridge structure was most unusual in this respect. From the series of diagrams (figs. 3.12 - 3.15: 3.12 - 3.14 are of structures which were recognised as innovatory and daring in their own day), it can be seen that the ratio of span weight to pier weight was very high in the Tay Bridge, and that the piers were very light for a structure crossing a wide estuary, very much lighter for example than the piers built for the Severn Bridge.

that an astute engineer, even if versed solely in British practice, could have detected that the structure was a sufficiently new departure to merit special investigation. Further clues that the bridge was inadequate to resist wind loads could have come from the experiences of engineers in America, (mentioned above), and from a fully comprehensive register of innovatory bridges at home and abroad. Unfortunately for Bouch none of these aids were readily available to British engineers in the 1870s although the source material was all accessible in one form or another.
